OSSTEM Clinical Cases

TS III SA / GS III RBM / GS II RBM / GS Ultra-Wide RBM

Early loading of implants in partially edentulous mandible

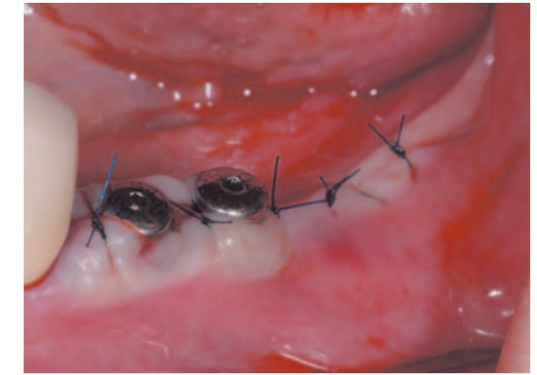
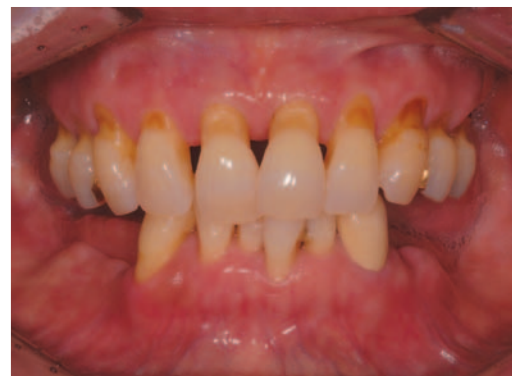
Fig. 6)

Fig. 6-8) $\overline{4}$ TS III SA ϕ 4.0 x 11.5mm (ISQ 68),
 $\overline{5}$ TS III SA ϕ 4.0 x 10mm (ISQ 82) were installed.

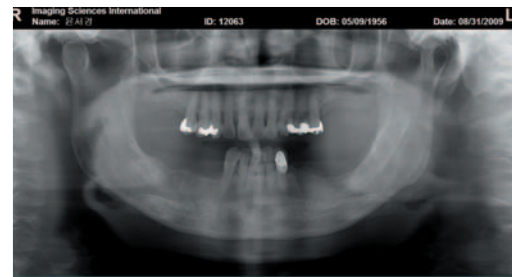
Fig. 1)

Fig. 1-2) The patient visited the clinic chiefly complaining of mastication troubles owing to the loss of the mandibular premolar and molar teeth. Due to the financial condition of the patient, recovering teeth only up to the premolar teeth was planned.

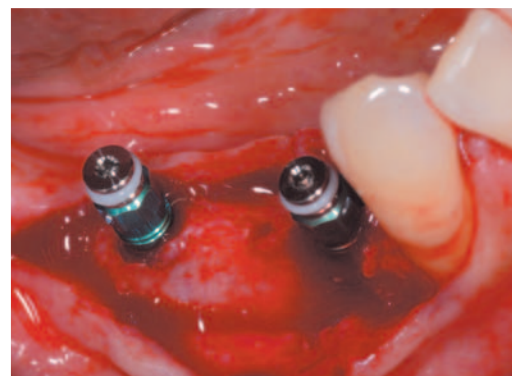
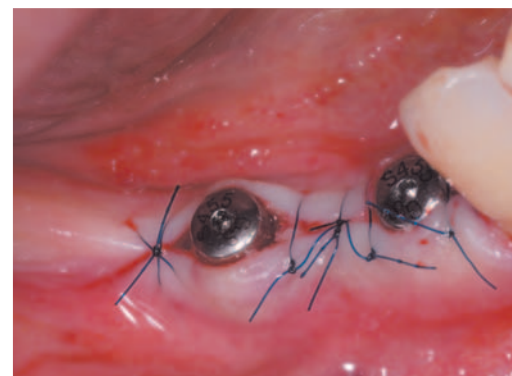
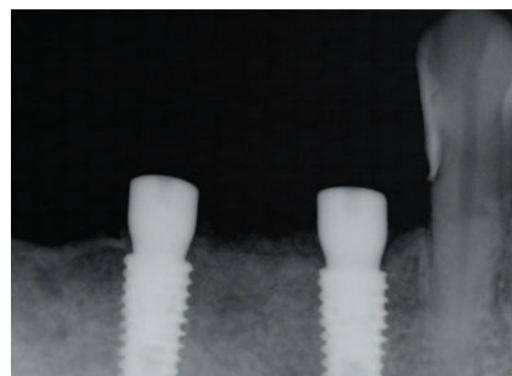
Fig. 3-5) $\overline{4}$ TS III SA ϕ 4.5 x 11.5mm (ISQ 83),
 $\overline{6}$ TS III SA ϕ 4.5 x 10.0mm (ISQ 81) were installed.

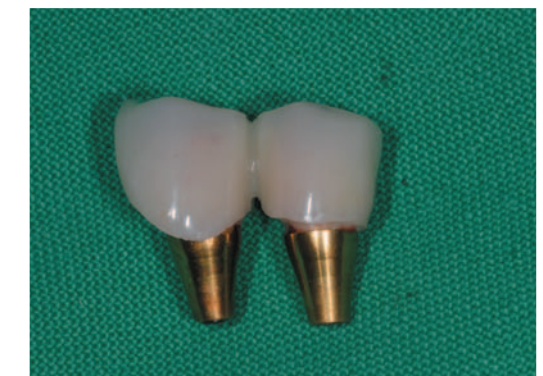
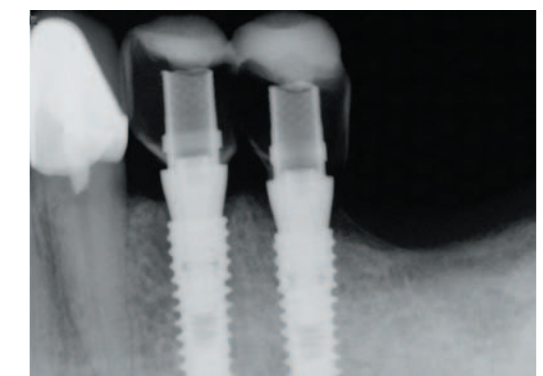
Fig. 9-12) Two weeks after implantation, early loading was tried with temporary bridge (ISQ 85 each).

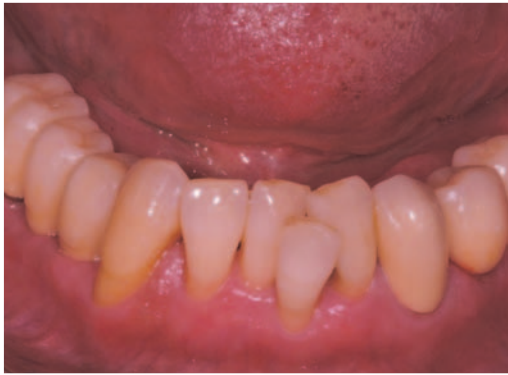
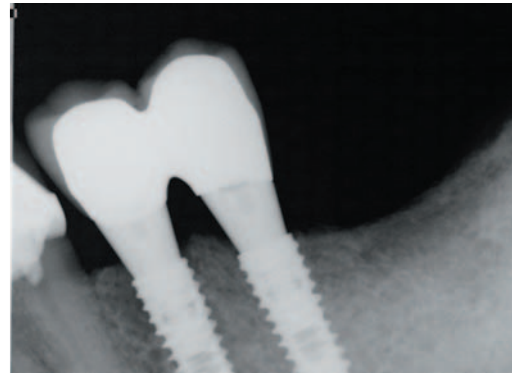
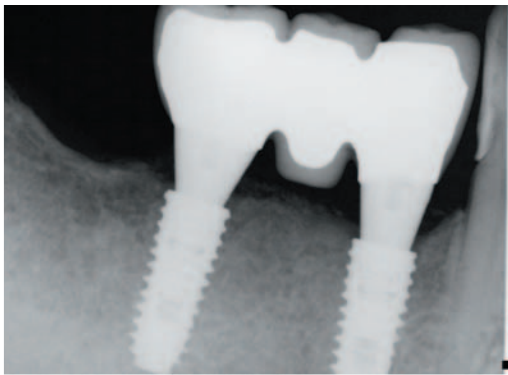
Fig. 13-15) Final bridge was delivered 2 months after implantation.

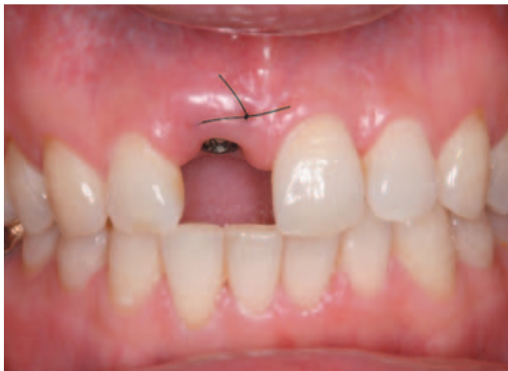
Fig. 3) After atraumatic extraction, GS III ϕ 4 x 13mm fixture was placed. The implant position was under the incisal edge, which corresponds to the palatal incline to the root, and a 4-mm height healing abutment was connected.

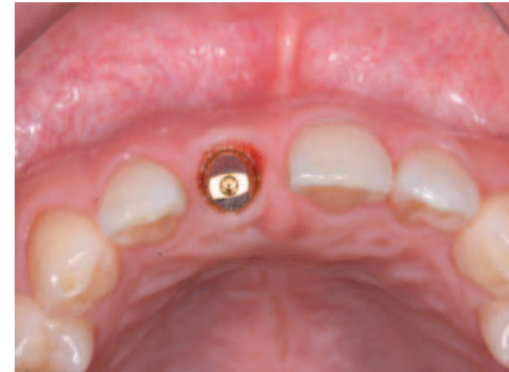
Fig. 7) The abutment was modified in the oral cavity with a high-speed bur as natural tooth preparation. The prepared abutment was re-tightened to 30Ncm to prevent screw loosening.

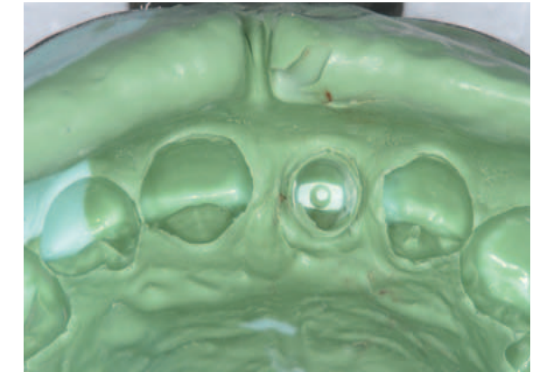
Fig. 8) The gingiva was retracted using a Retraction cap; A conventional closed-tray impression was made by the direct impression method.

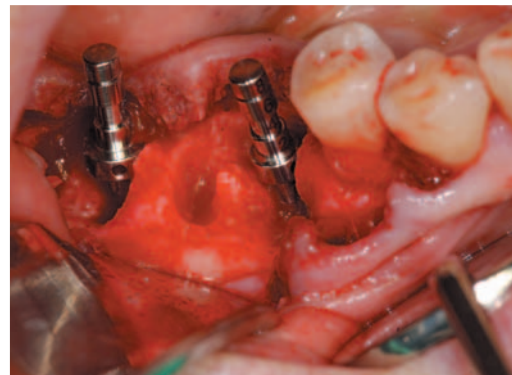
Fig. 4) After pilot drilling, guide pins were inserted to check the paths. Notes the bone resorptions.

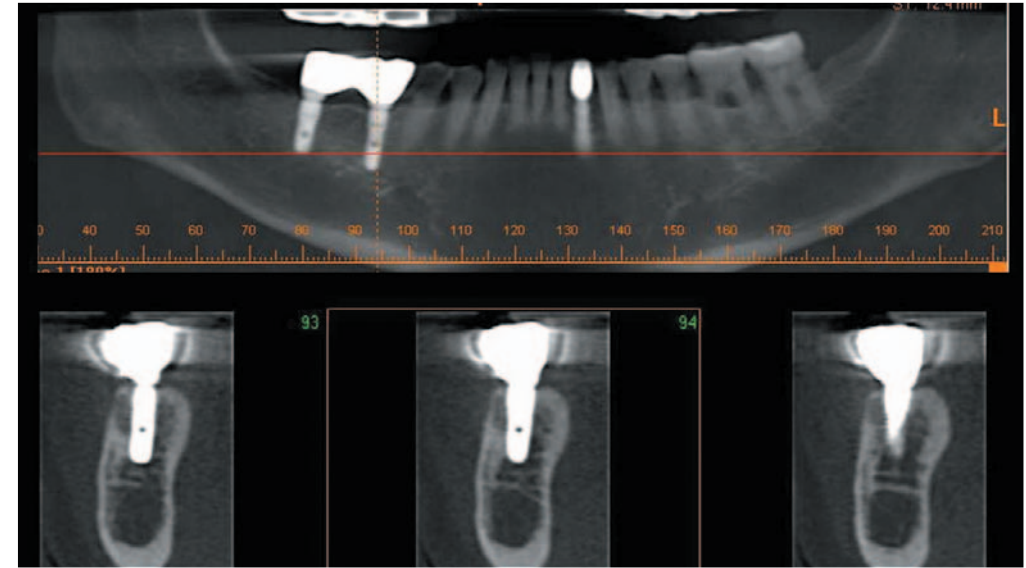
Fig. 19) C.T. images of the 6 area, 13 months after installation of the prosthesis; note that bones were formed well on the buccal side.

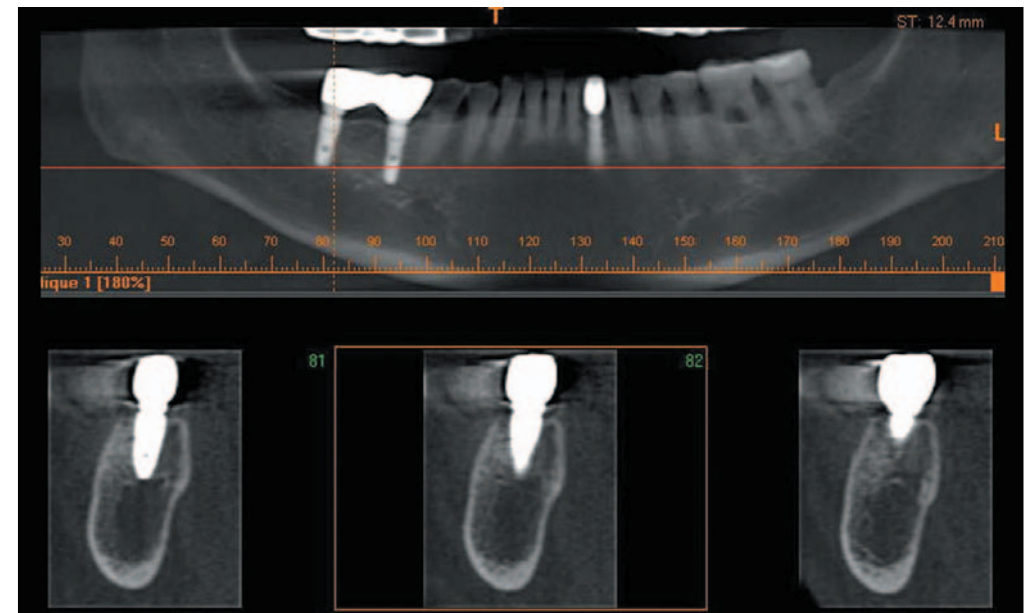
Fig. 20) C.T. images of the 7 area, 13 months after installation of the prosthesis.

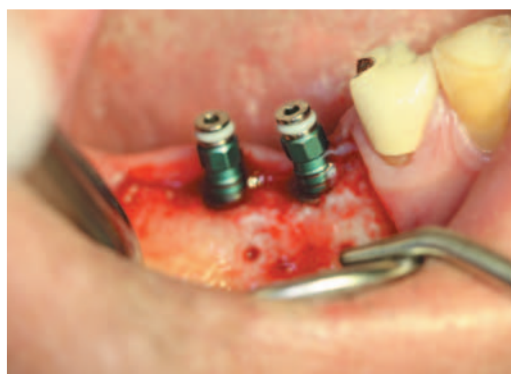
Fig. 3) View of implants (GS III) after the implantation. Early fixation was excellent. Thus, immediate loading was attempted. $\overline{6}$ ϕ 4.5 x 11.5mm (ISQ: 77), $\overline{7}$ ϕ 5.0 x 11.5mm (ISQ: 86).

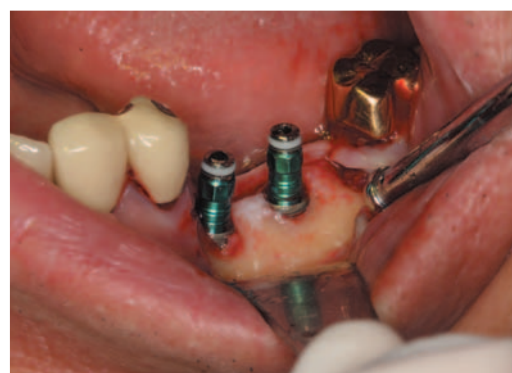
Fig. 6) View of implants (GS III) installed into $\overline{5}$ $\overline{6}$ areas based on the one stage method. Although the initial fixing power was excellent, treatment plan was changed (from immediate loading to early loading) due to cost issues. $\overline{5}$ ϕ 4.5 x 11.5mm (ISQ: 81) $\overline{6}$ ϕ 4.5 x 11.5mm (ISQ: 88).

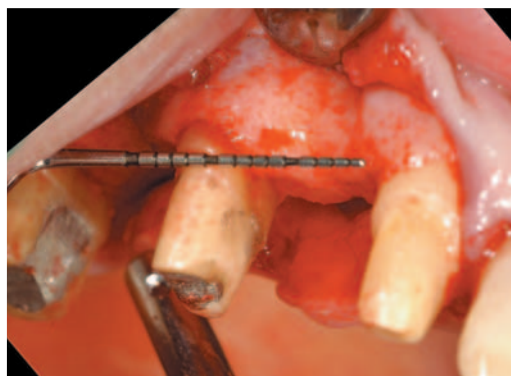
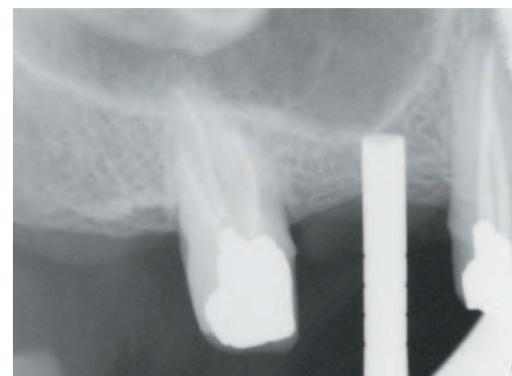
Fig. 3)

Fig. 3~4) Crestal approach.
(Autogenous bone & Bio-Oss® graft)

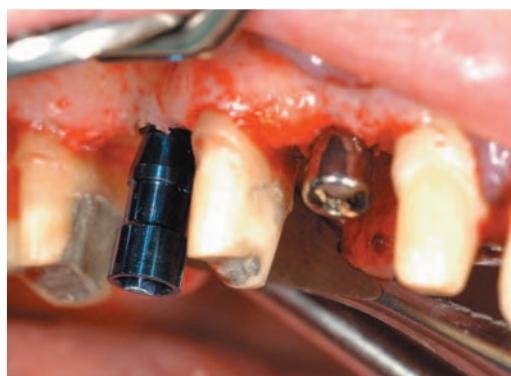
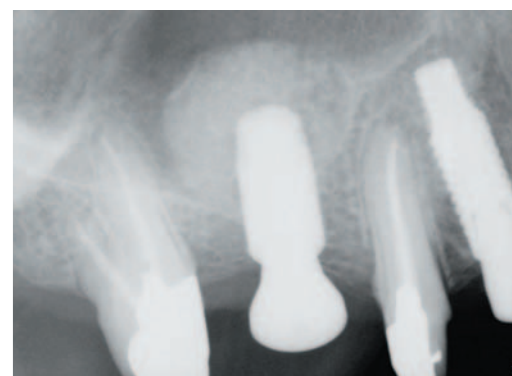
Fig. 5)

Fig. 5~6) GS II ø 5.0 x 10mm.

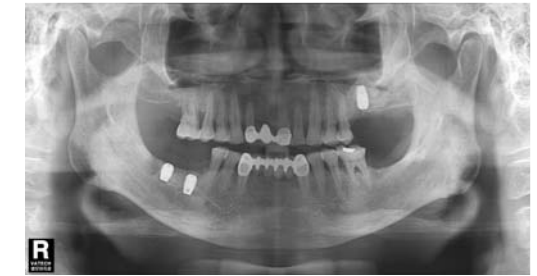
Fig. 7)

Fig. 7~8) $\overline{6}$ the lateral window approach was used with GS Ultra-Wide $\phi 6.0 \times 10.0\text{mm}$ implant placement, while using Nu-oss[®] as bone graft material. Since the initial fixation was not good, the prosthesis was installed 8 months after the bone graft.

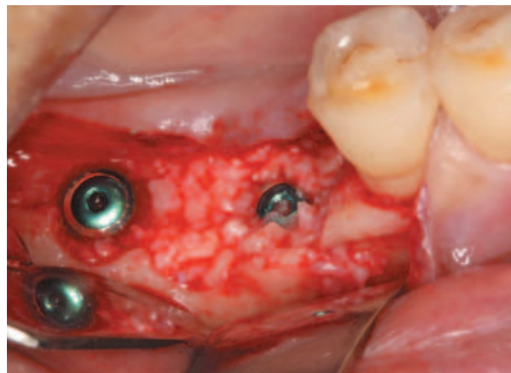
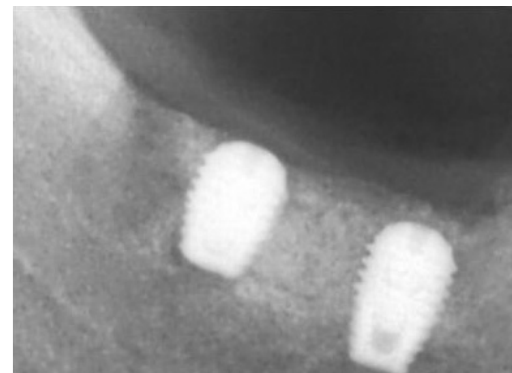
Fig. 3)

Fig. 3~4) $\overline{6}$ GS Ultra-Wide $\phi 6.0 \times 8.5\text{mm}$, $\overline{7}$ GS Ultra-Wide $\phi 6.0 \times 7.0\text{mm}$ $\overline{6}$ sureoss[®] chips (cortical bone) and surederm[®] were used.
